## **"Selectric" Typewriter**

### **Print Quality Review**

**Z241-6288-0**

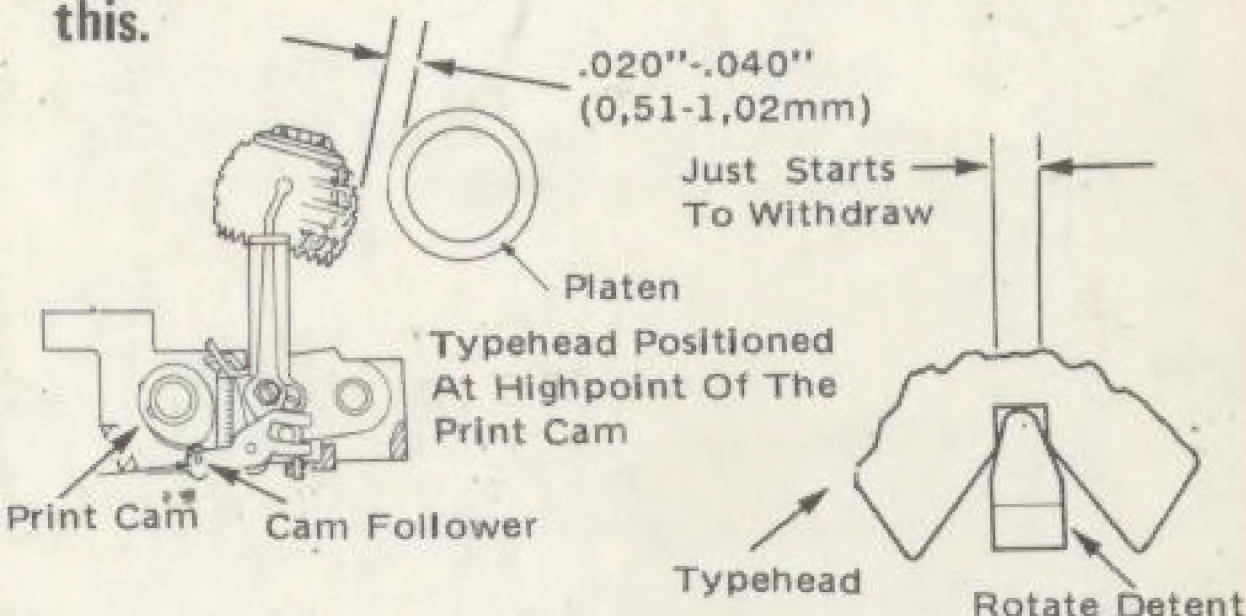
# DETENT CAM FOLLOWER BRACKET ADJUSTMENT (For Smears And Tails)

Adjust the detent cam follower mounting bracket up or down so the rotate detent just begins to withdraw from the typehead when the typehead has moved .020"-.040" (0.51-1.02 mm) away from the print position (high point of the print cam.) Use a tilt 2, rotate 0 character to observe this.

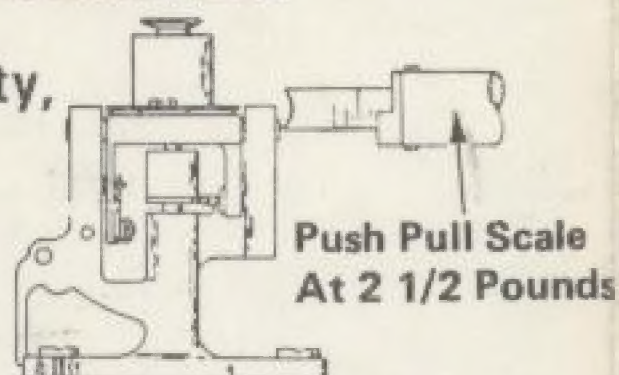
## TILT RING ADJUSTMENT

To ensure good print quality, a certain preload on the tilt ring is necessary.

### Method To Be Used:

Position Carrier At Left-Hand Margin

Loosen The Pivot Pins Locking Screws

Replace Springs
